## Detection issues at perimeter exit solved with above ground vehicle sensor

The subsiding ground caused detection problems with the induction loop at a site exit. After installing our **OPTEX OVS-02GT** above-ground vehicle detection, the exit is functioning properly again.

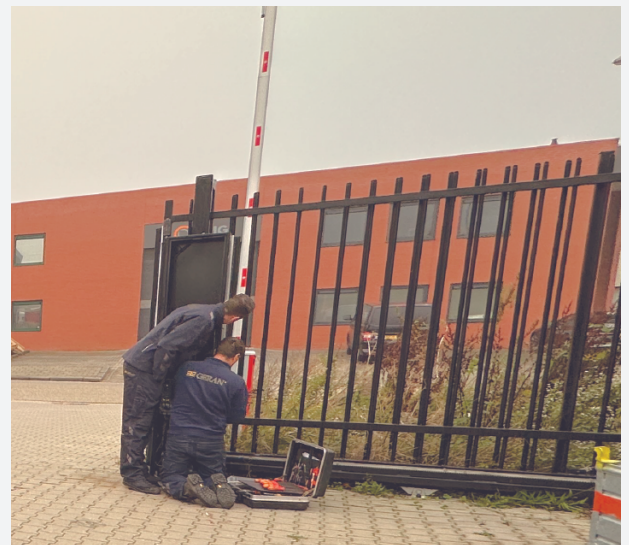
The company is located on a site formerly zoned for municipal storage, consisting mainly of mud and loose ground. When Van der Panne started using the site, it was paved and protected by a fence with an automatic sliding gate and barrier. An induction loop was installed for vehicle detection. This worked satisfactorily; though unfortunately, the ground started to subside.

Recently, the ground loop was no longer functioning accurately, likely due to the subsidence. Van der Panne raised this issue with Geran Handel B.V., and together they began searching for an alternative solution for vehicle detection to address future subsidence and the potential problems associated with it. While the repair is necessary, Van der Panne is hesitant because it would mean that the exit cannot be used for several hours or even days, and multiple companies would need to collaborate simultaneously to fix the current application.

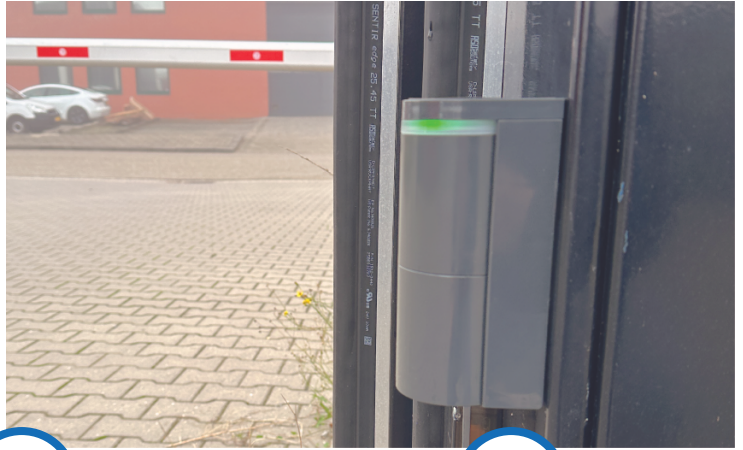
The primary issue at the site is the unstable ground, making above-ground vehicle detection more suitable. Geran Handel B.V. has had positive experiences with our OVS-01GT, so there was no hesitation in introducing our recently launched OVS-02GT, which offers a larger and more accurate detection area for vehicle detection. The OVS-02GT also disregards pedestrian traffic to prevent unwanted gate and barrier openings. Mounting the sensor on the gate control housing

and using the installation app for setting adjustments was a quick and straightforward process. The system was up and running again in no time, with only one party involved in installing the new sensor solution.

This sensor is ideal for areas with subsurface issues like flooding or subsidence. The above-ground design, IP-66 rating, and built-in heater ensure weather proof operation.

Installation is easy and settings are quickly modified with the installation app. The site stays accessible during installation and groundwork is avoided.

This presence and activation sensor detects vehicles up to 35km/h (22mph), has a range up to 8 meters (26ft) and can ignore pedestrians to prevent unwanted openings.
