## MULTISTRAND CARBON RIGGING

Introduced to the market in 2004 **ECsix** swiftly became the go-to product when looking for high performance composite rigging. Since its inception **ECsix** has been installed on over 600 yachts and has not had a single failure due to age, wear, weather or water ingress and remains the most proven carbon rigging available.

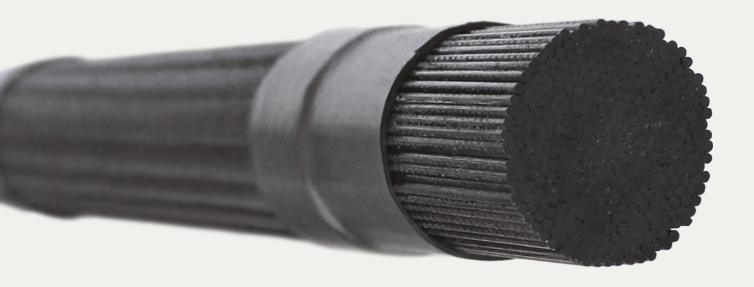
**ECsix's** unique multistrand construction provides an unbeatable combination of strength, frontal area and durability offering the perfect balance between performance and longevity. **ECsix** has been tested at all levels of yachting from the *Volvo Ocean Race, IMOCA 60s, TP52s and Mini Maxis* through to the world's largest superyachts.
